MMA Memo 100

Temperature Measurements On BIMA 6-m Antennas— Part I: Backing Structure

James W Lamb[1] and J. R. Forster[2]
16 August 1993

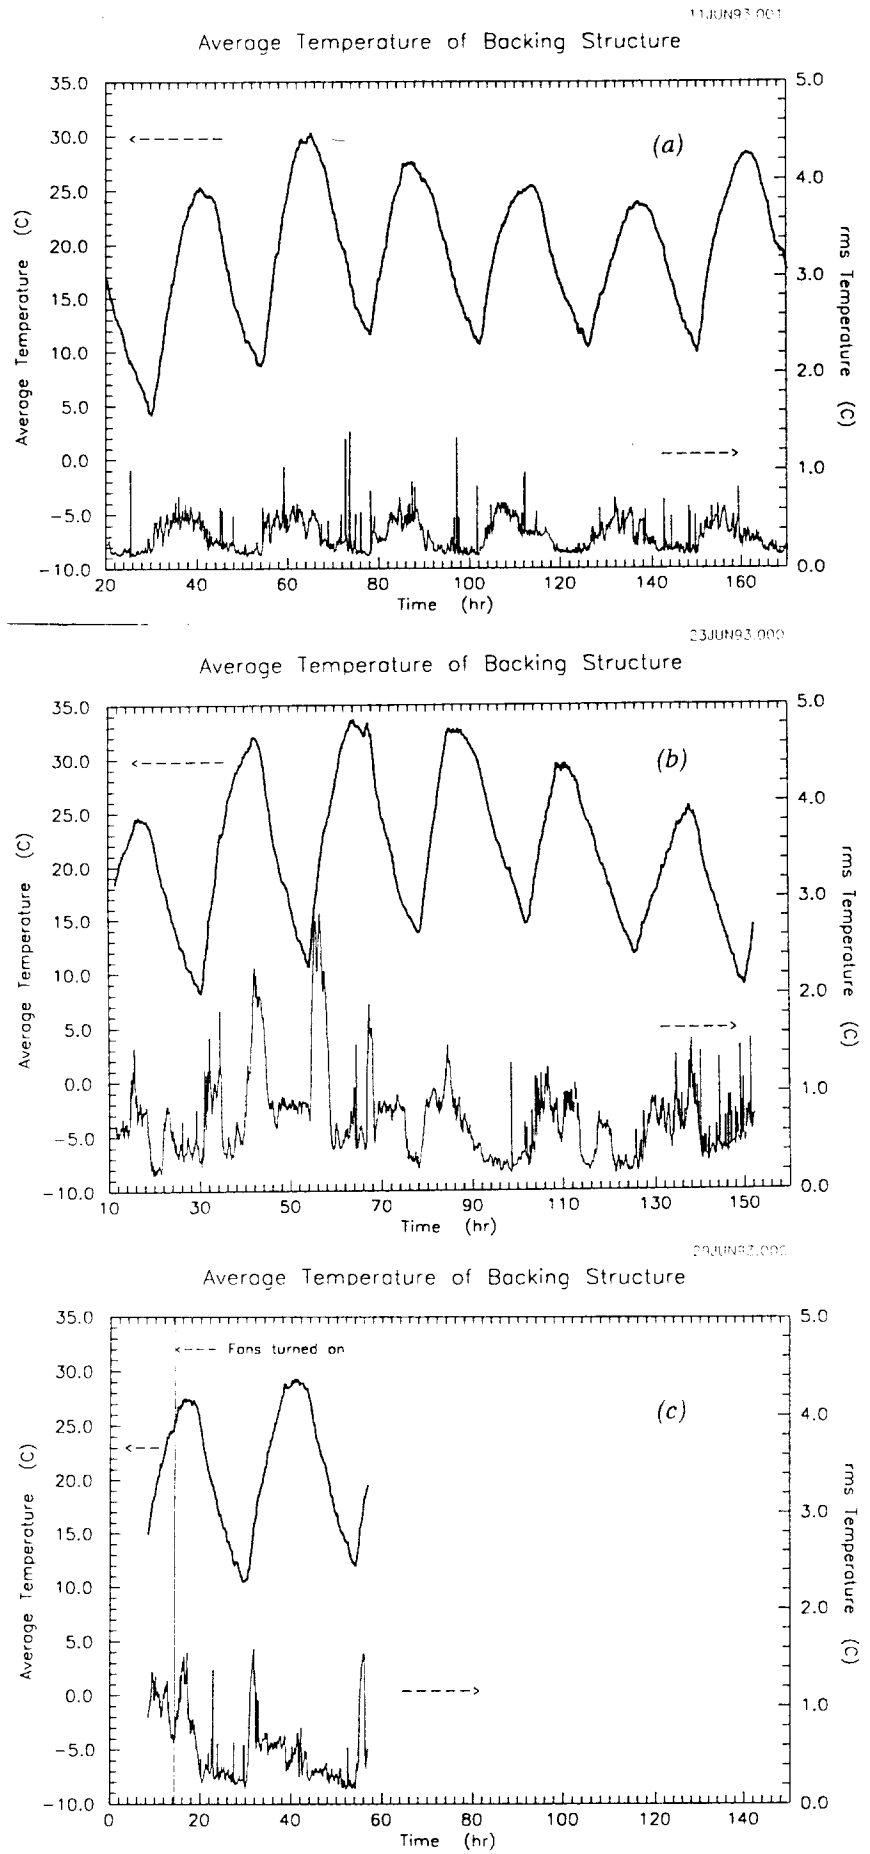
Figure 3. Average temperature in the backing structure, and rms variation of sensor readings from the mean.

Figure 3*a* shows the average temperature in the BS. It follows a regular diurnal cycle over a range of about 25 C. During the day the rms variation in temperature among the thermistors typically reaches 0.8 C, while during the night a value of around 0.2 C is observed.

Figure 3*b* gives the average and rms BS temperatures. While the average is similar to that for the 11 June data the rms is higher by a factor of three to four.

Conditions were the same as for the 23 June data, except that the fans were restarted in the afternoon. Two days' of data were taken. Figure 3*c* shows the average and rms temperatures over the period. Although the data are not unambiguous because of the short time, there is some evidence that turning on the fans reduces the temperature gradients, even with the sunshades removed. The difference temperatures in Figure 6 also show some improvement compared to no fans or sunshades.

(a) 11th June 1993, fans and sunshades on.

(b) 23rd June 1993, fans and sunshades off.

(c) 29th June 1993, fans on and sunshades off.

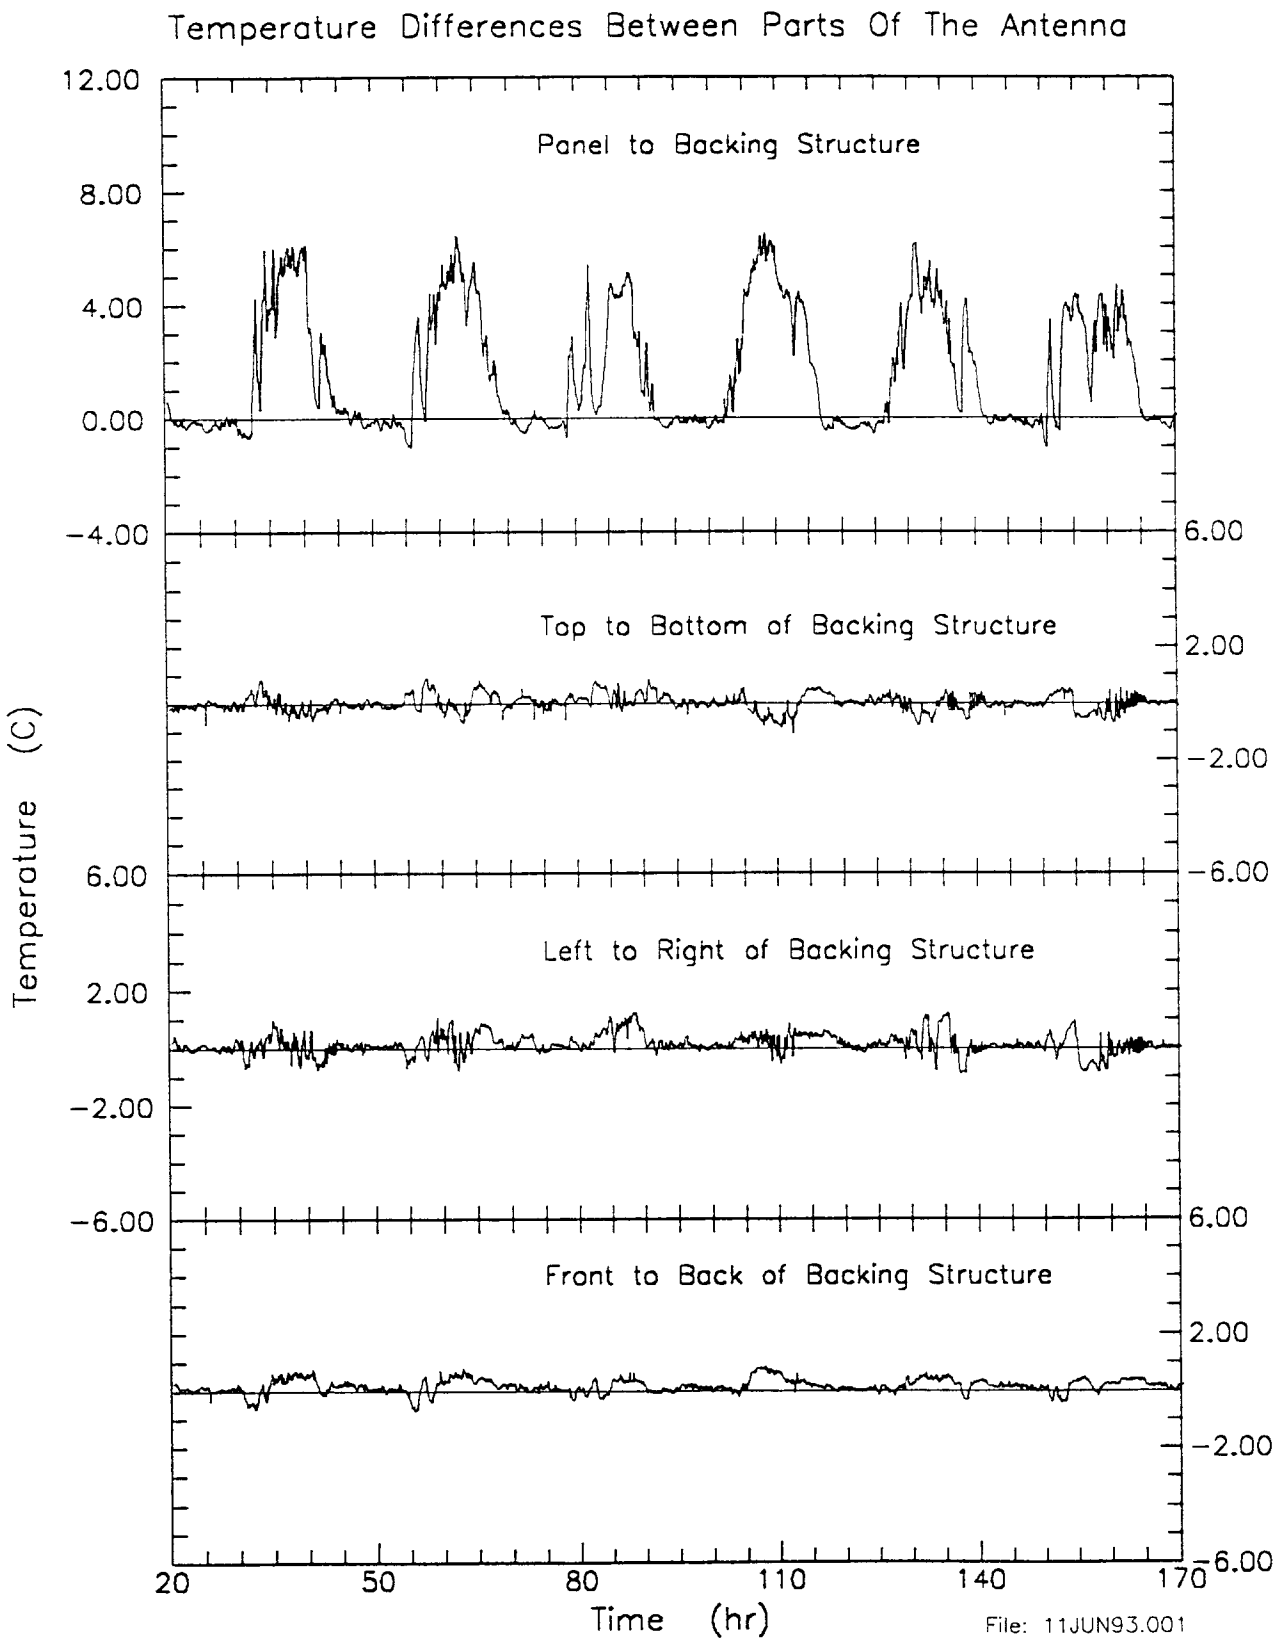
Figure 4. Differences between parts of the BS for 11th June 1993 data, fans and sunshades on.

Figure 4 shows the temperature differences between different parts of the antenna structure. For example, the top-to-bottom difference is the difference between the average of the eight sensors on the truss on the top of the backup structure and the average of the eight sensors on the truss on the bottom side. The most extreme excursions are in the panel, as expected since the panel has only moderate solar reflectivity and is loosely coupled with the BS. Differences between other parts of the structure typically have extreme values of about 1 C. For left-to-right and top-to-bottom differences this is an average gradient of about 0.25 C m^{-1}, and for front-to-back differences it is about 1.3 C m^{-1}.

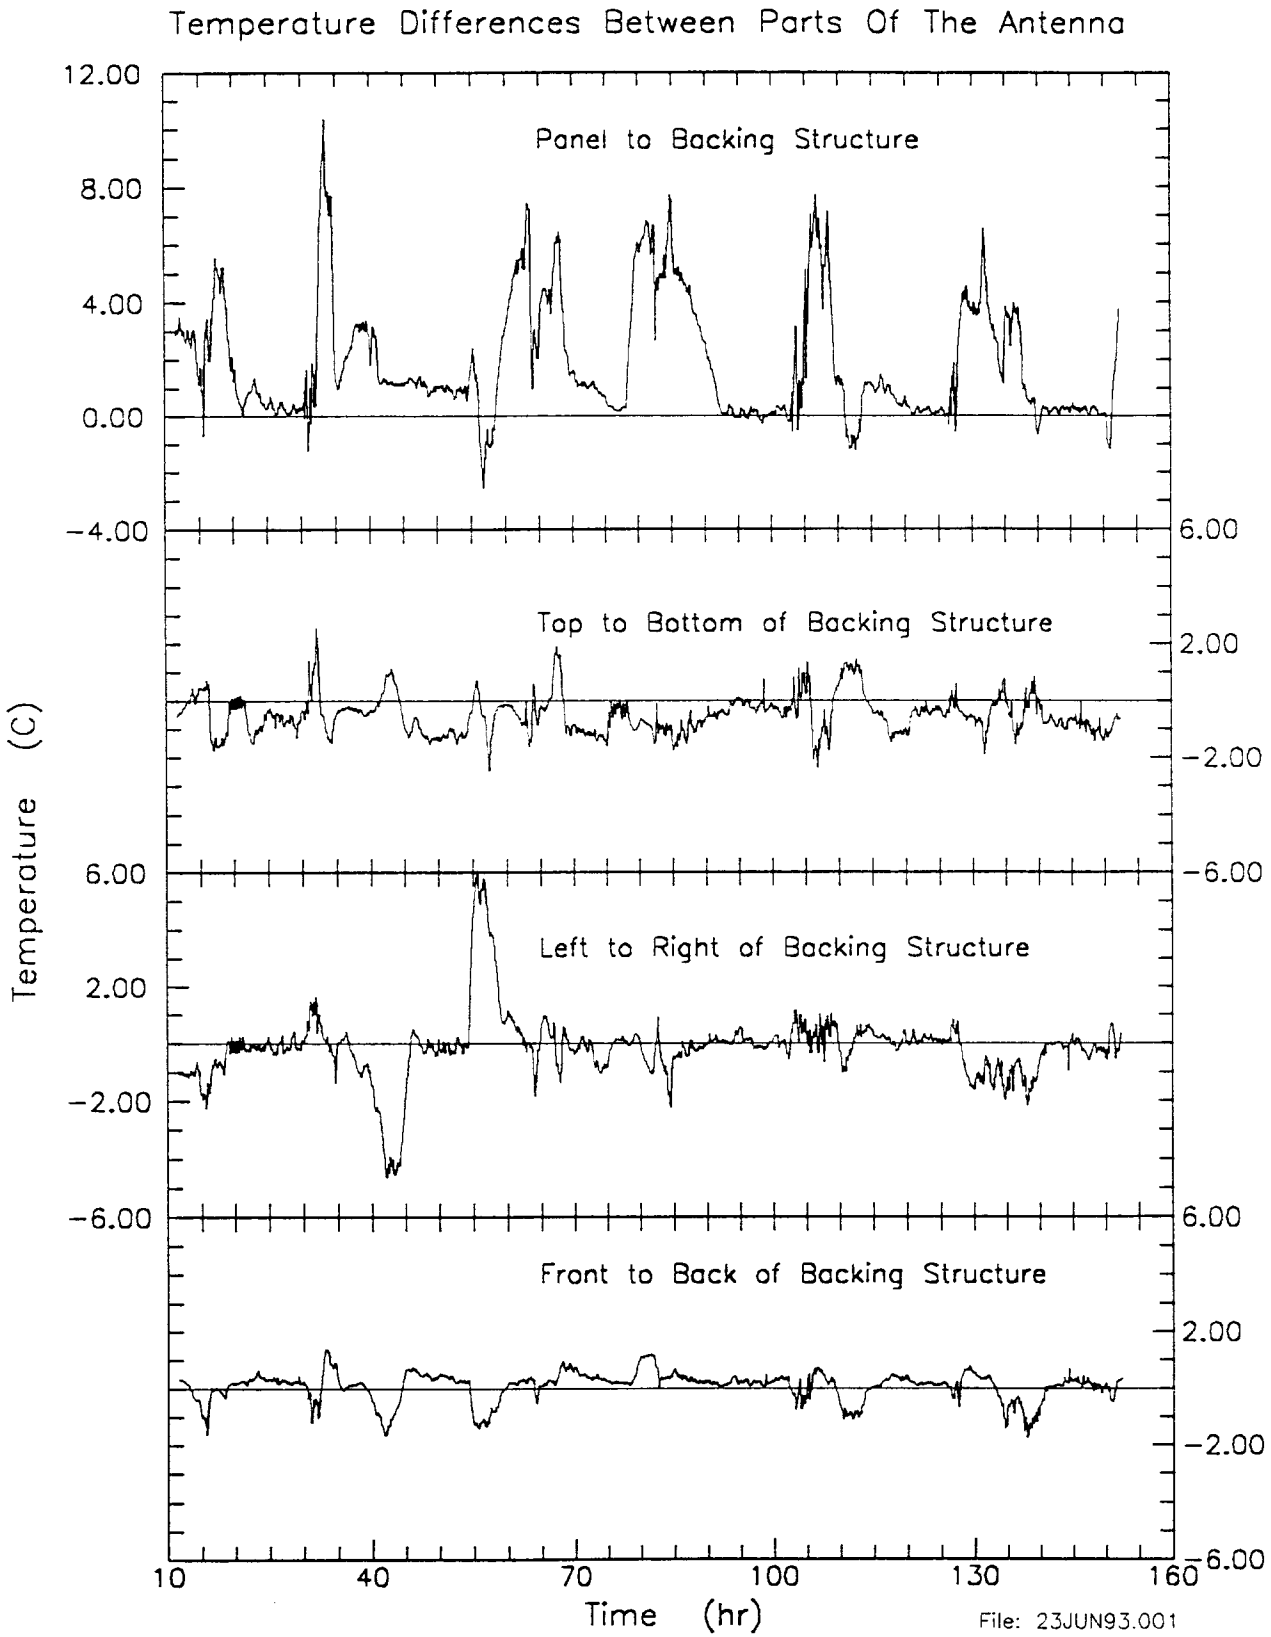
Figure 5. Differences between parts of the BS for 23rd June 1993 data, fans and sunshades off.

Difference temperatures are shown in Figure 5. Again the panel shows the largest differential, but there is also a significant difference between other parts of the antenna, notably the left-to-right measurements. The top-to-bottom difference is not as large but has a bias in the negative direction, showing that the top of the structure is *cooler* than the bottom. Although the sign is surprising, the stratification may be expected as the antenna was pointed at the horizon during the measurements. Gradients are up to about 1.5 C m^{-1} top-to-bottom, 0.75 C m^{-1} right-to-left, and 2.6 C m^{-1} front-to-back.

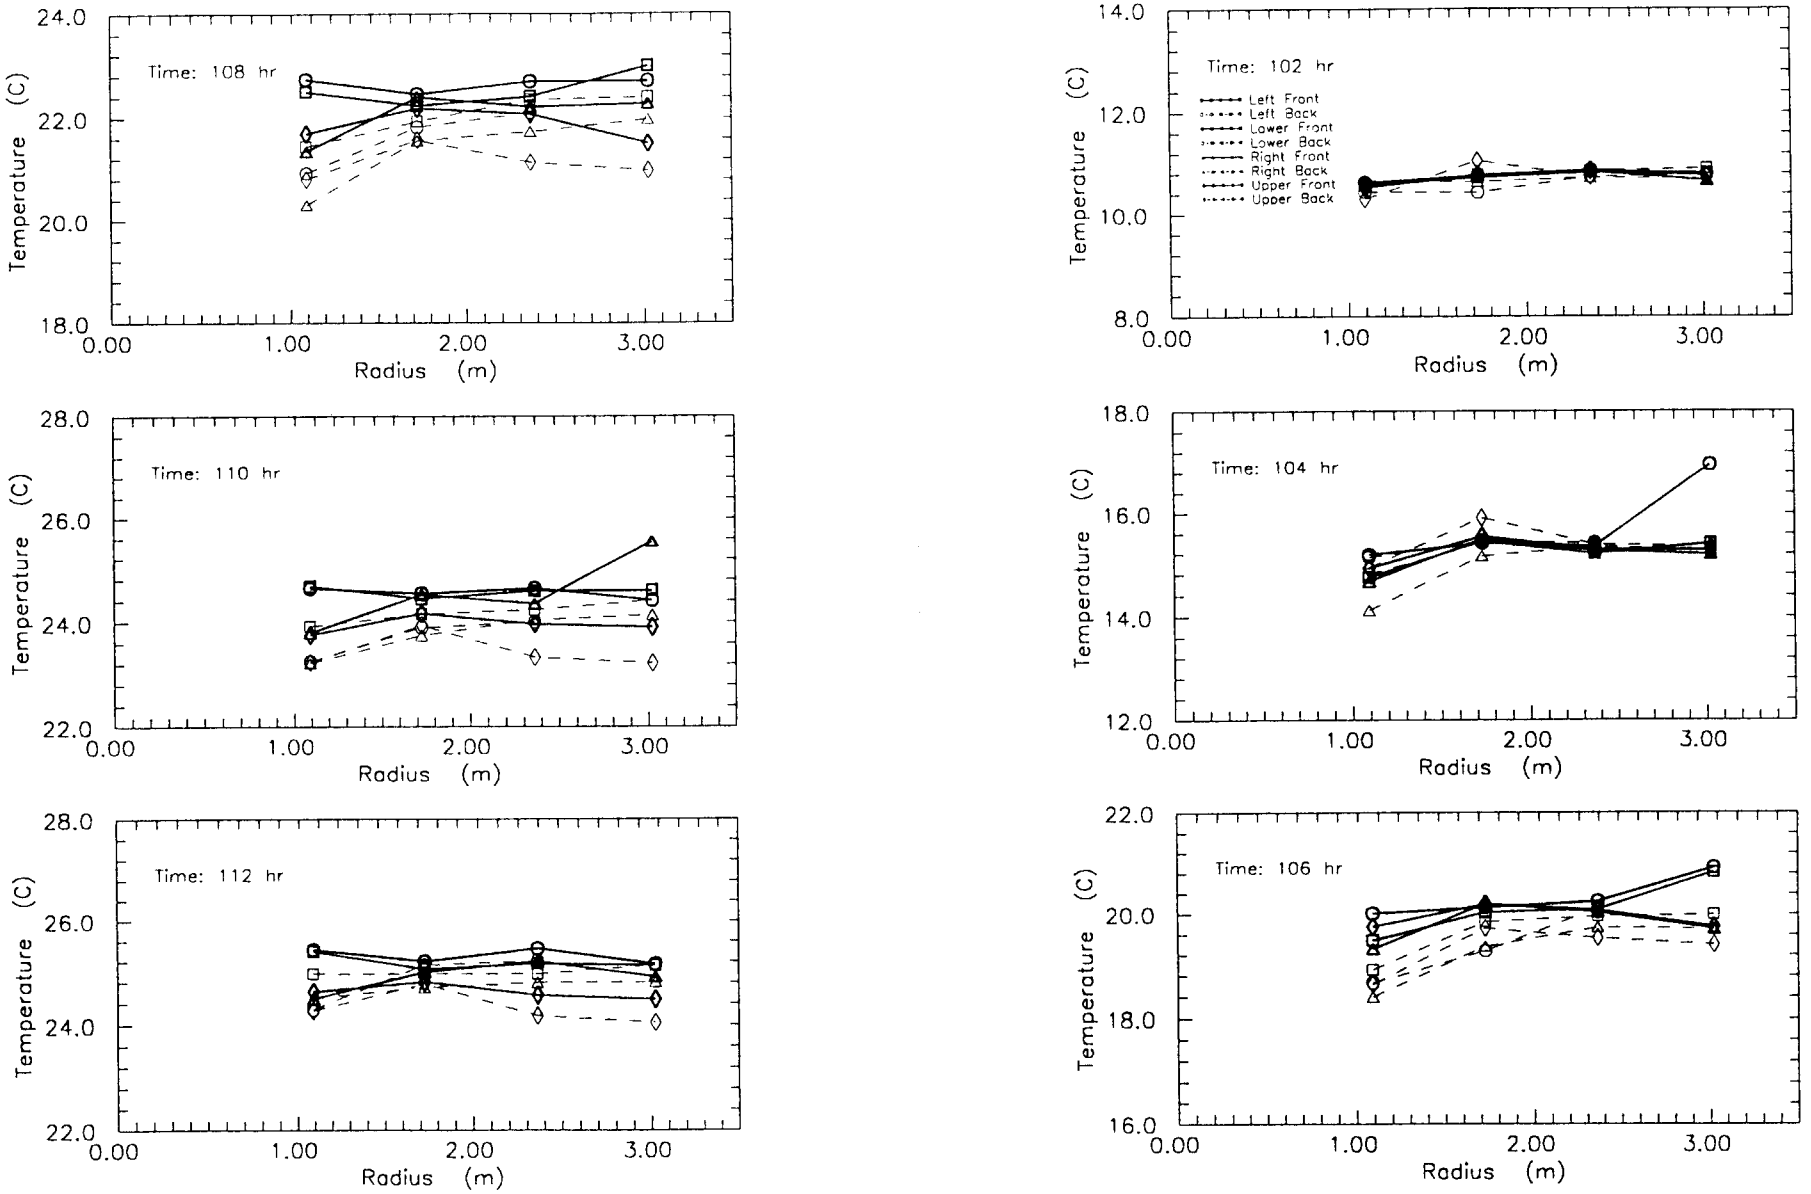
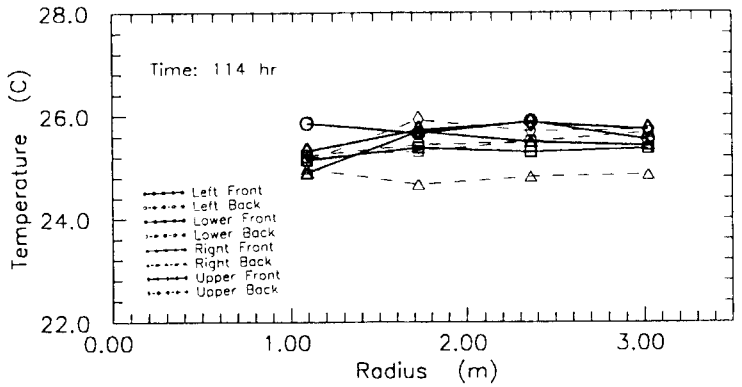
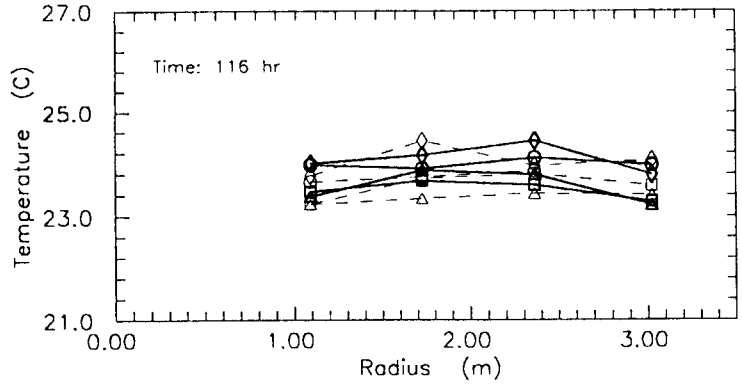
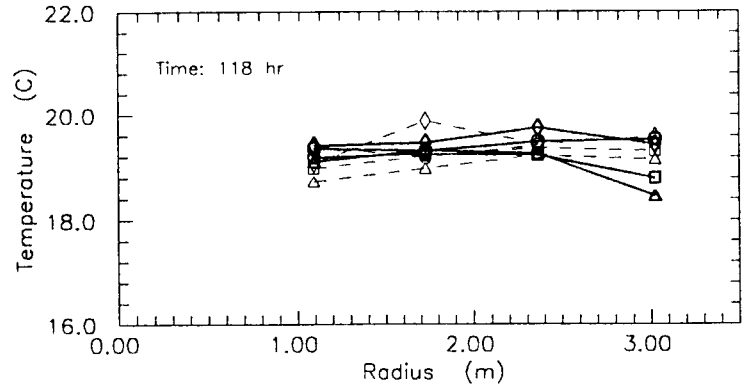
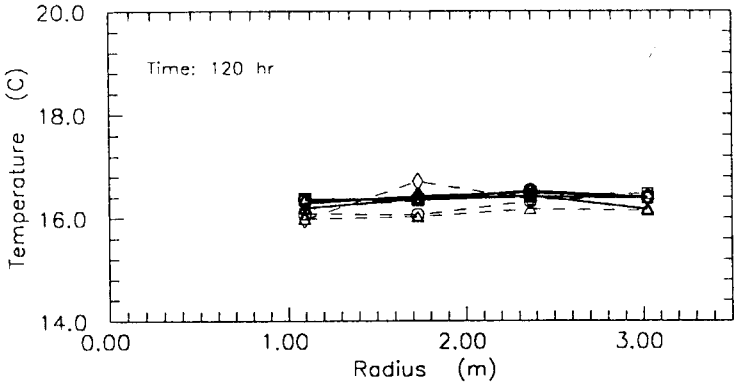
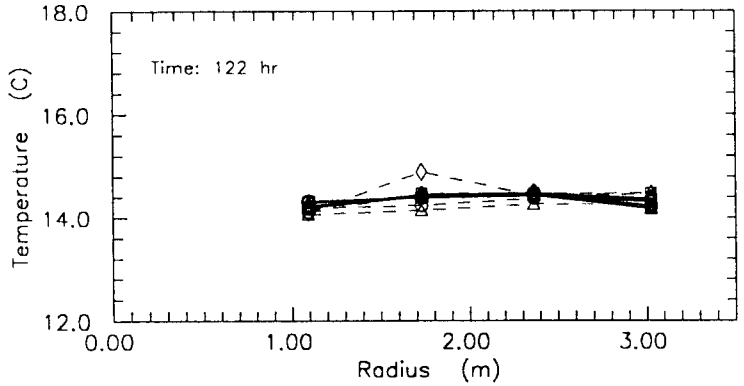
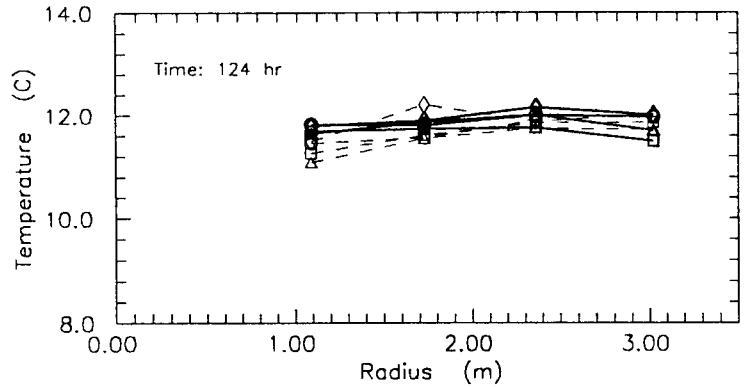
Figure 7. Temperature plotted as a function of radial distance along truss for the four trusses, front and rear. For 11th June 1993 data, fans and sunshades on.

The effects of the temperature on the surface accuracy, pointing, *etc.* will depend on the precise temperature distribution. Figures 7 and 8 show how the temperature varies as a function of radial distance along the trusses for some typical conditions. For each of the data sets there is a set of graphs covering a 24-hour period in two hour intervals. When the sunshades and fans are used the backing structure temperature is very uniform during the night (from about 10 p.m. to 6 a.m.), the maximum differences being less than 1 C. During the morning (6 a.m. to noon) the antenna starts to warm up, starting at the rim so that a gradient develops between the center and edge of the dish. At the same time some difference arises between the front and rear of the backing structure. By the middle of the day the radial gradient is reduced but the front-to-back difference is still significant. There is also some scatter in the temperatures that is not very systematic. In the afternoon the temperature falls, slightly faster at the edge than the center.

An unexpected feature is the discontinuity that arises at the outer section of the dish where the temperature drops significantly. It may be because the structure can lose heat through the edge as well as the back and front surfaces.

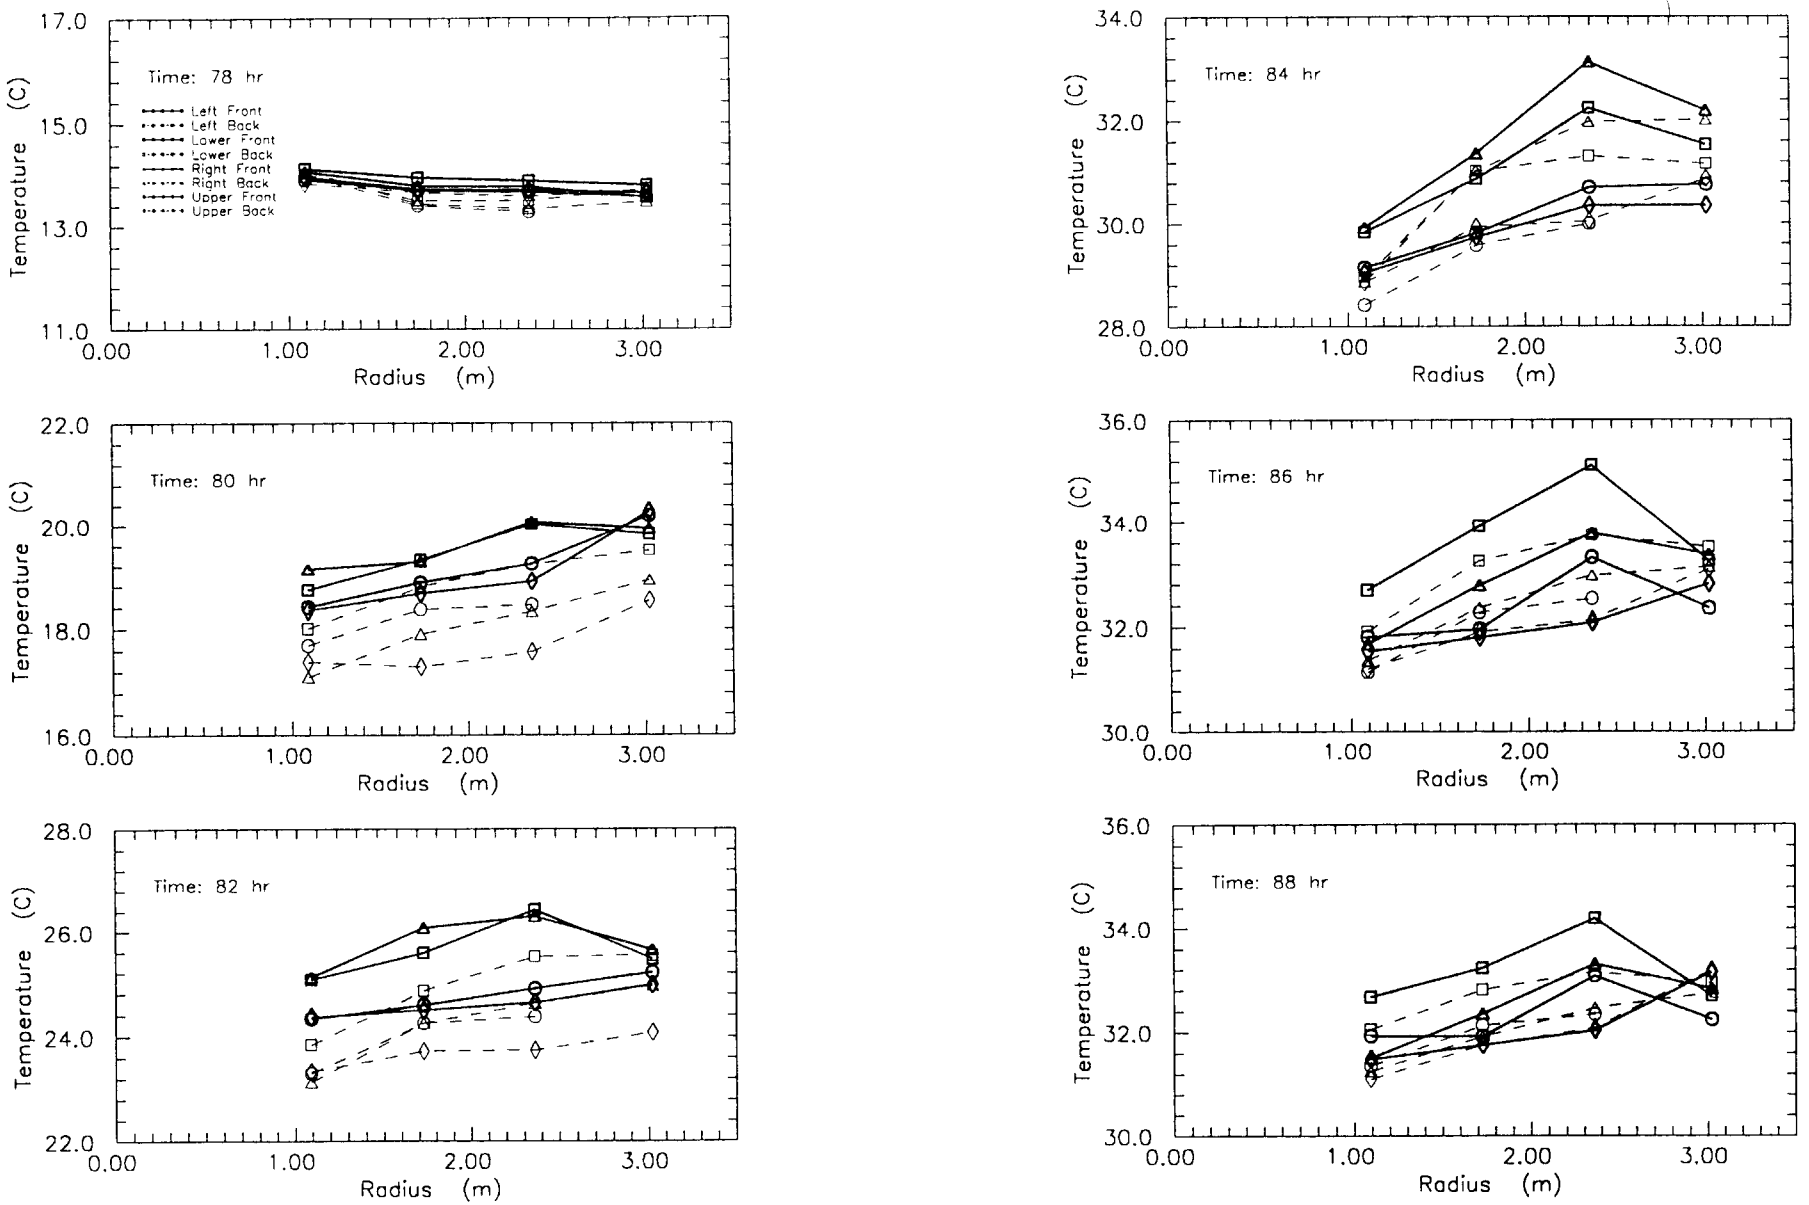
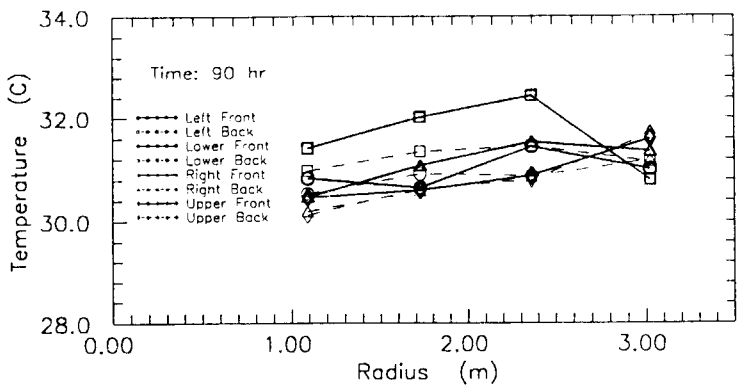
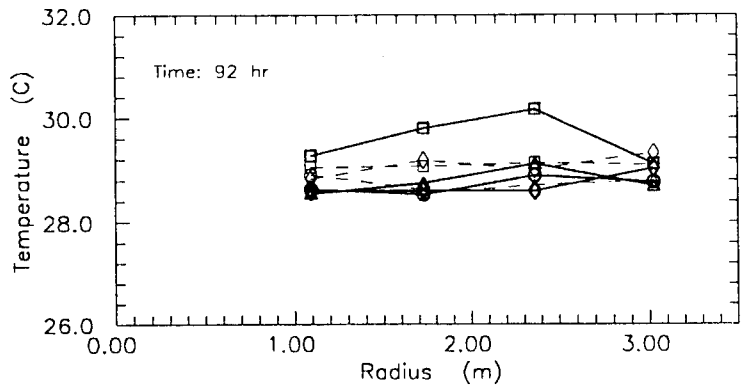
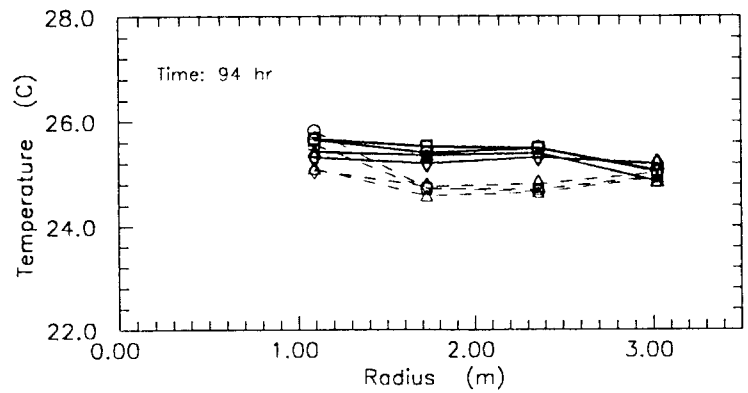
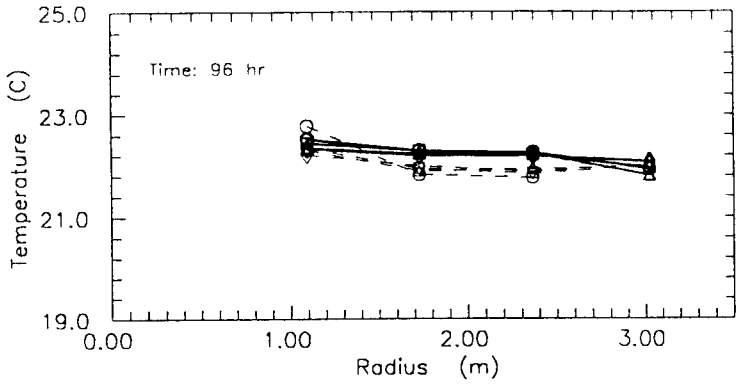
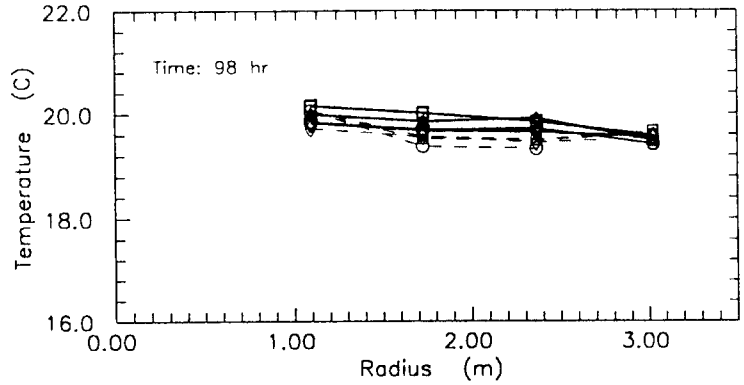
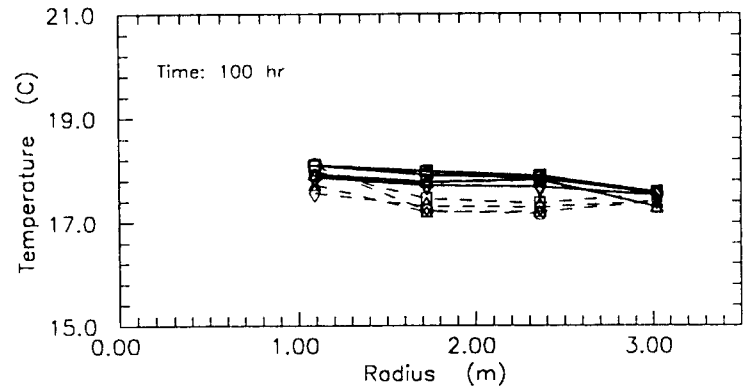
Figure 8. Temperature plotted as a function of radial distance along truss for the four trusses, front and rear. For 23rd June 1993 data, fans and sunshades off.

Without the sunshades the temperature gradients are more dramatic. Nighttime temperatures are still fairly uniform, though there is still an appreciable difference between the front and the back of the structure (of order 1 C) and an observable radial gradient. In the morning a radial gradient, increasing towards the edge, is evident. This can be as high as 2 C m^{-1}, and may be due either to the lower timeconstant of the central cone, or to the influence of the receiver cabin temperature control. The front-to-back difference is on the order of 1 C.
